Date: 19 June 2000

Hog 1000/500 Program card LED flickering

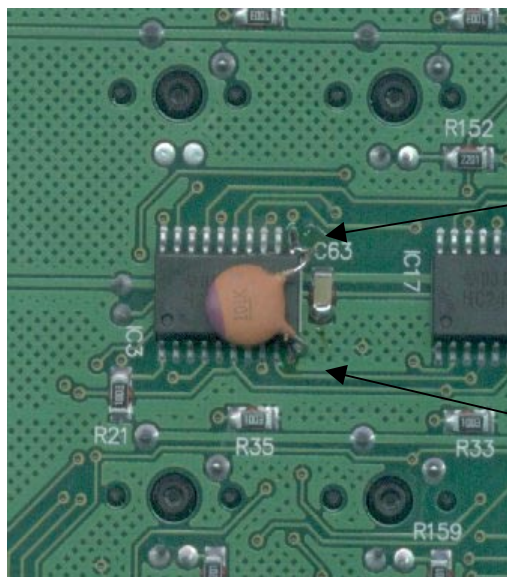
The LEDs on the program card have been found to flicker randomly during test and normal operation.

Add a 100pF capacitor to the back of the program PCB, from IC3 pin 10 to IC3 pin 11.

1. On the solder side of the program PCB locate IC3 (74HC573).
2. Solder a 100pF 50 capacitor between pin 11 of IC3 and Pin 10 of IC3
3. Test before refitting the base.

Solder 100pF
capacitor
between pin
10 and pin 11
