Date: 14th October 1996

## EVENT PLUS KEYPAD FLASH

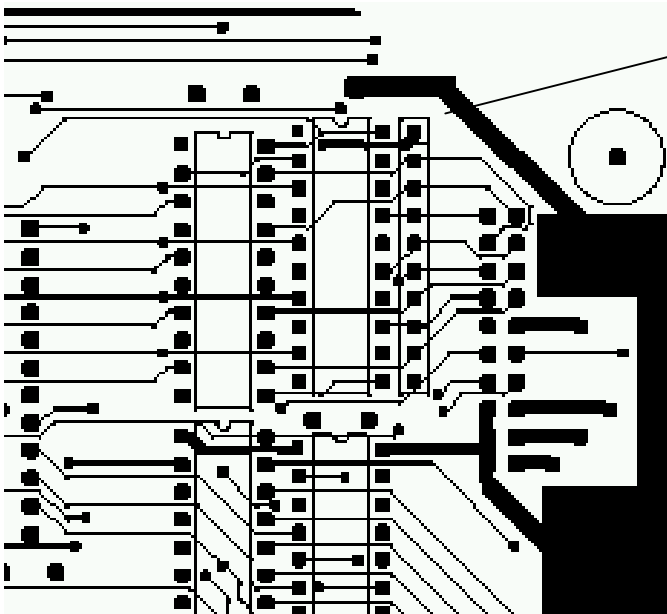
View From Solder Side

Under certain conditions the LEDs in the keypad buttons of the Event Plus console momentarily flash. This appears at random and has no adverse effect on the console operation, however it can be a distraction to the user. To fix this the CPU card needs to be modified as follows:

1. Remove CPU card.
2. Locate RS5 located between CN2 and IC14.
3. Cut track leading to pin 1 of RS5.
4. Link pin 1 RS5 to thick ground track nearby.
