Date: 1st December 1998

Echelon Main LCD backlight driver

T E C H N I C A L B U L L E T I N S H E E T

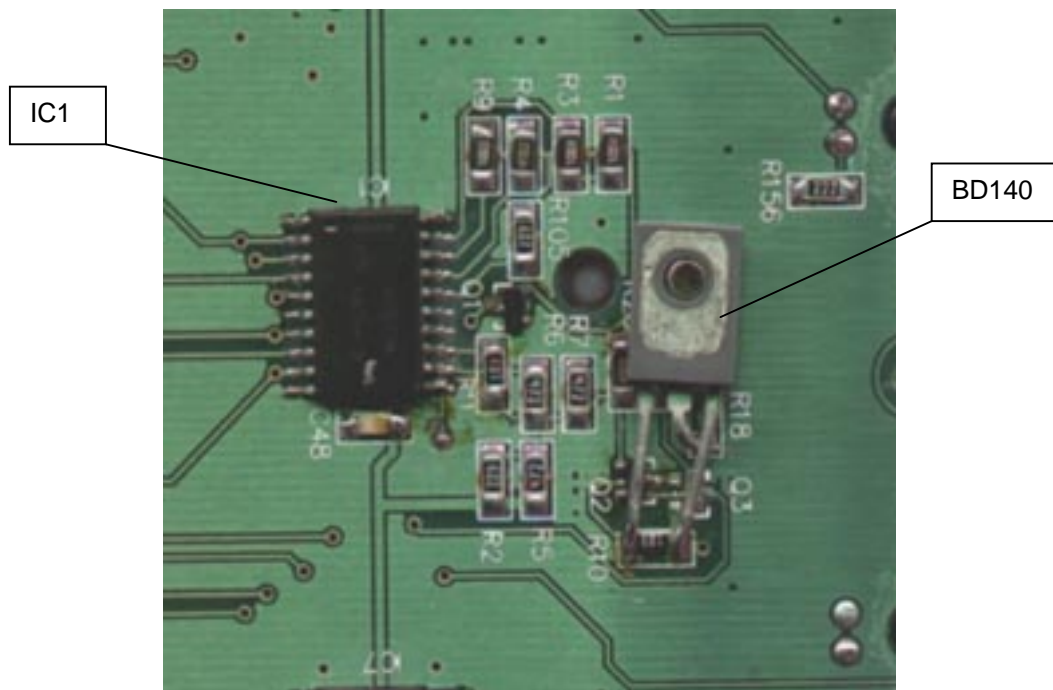
Transistor Q3 may fail prematurely when the main graphics LCD backlight is run at less than 100%, eg when set to either 0, 1 or 2 in the Setup-Panel display.

A minor shift in the backlight dimmer levels is be expected due to the different gain of the transistor. The diagram below shows a modified board.

Replace transistor Q3 on ECHPROG2 with a BD140. These are available from general electronics part suppliers.

1. On the solder side of the PCB locate the backlight dimmer circuitry close to IC1 (74HC573).
2. Locate and remove Q3 (marked T1p).
3. Locate the end of an M3 bolt that is used to hold the main LCD to the program card. The bolt is nearby Q3.
4. Place the BD140 over the bolt with the metal faced heatsink side upward.
5. Solder the centre lead of the BD140 to the end of R18 furthest from the bolt.
6. Solder the outer leads of the BD140 to either side of R10 such that they don't cross over.
