Date: 19 June 2000

Hog 1000 Backlight Transformer Mounting

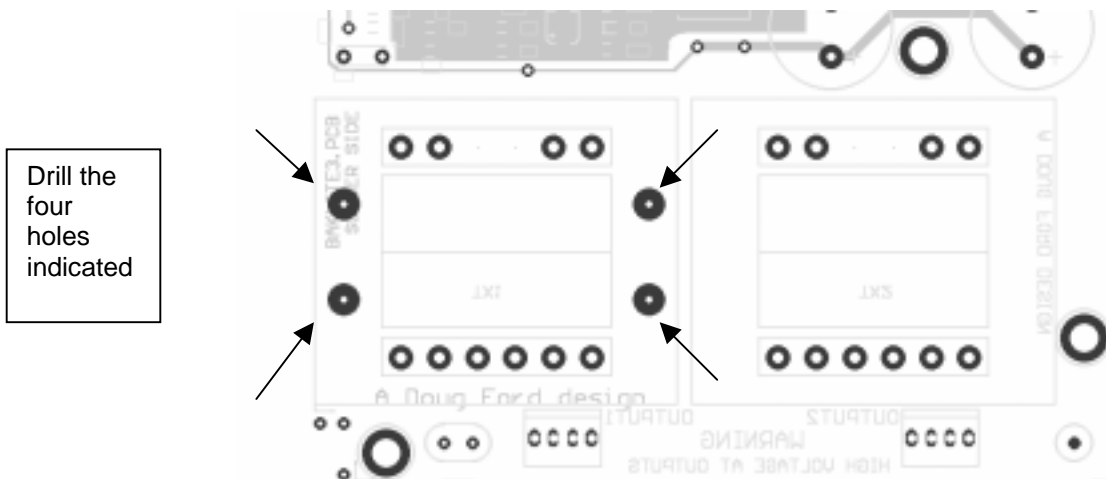
The large transformer used to supply backlight voltage to the HOG1000 and Echelon 1K character displays has been found to detach from the backlight driver circuit board during rough handling of the console. The loose transformer can damage the circuit boards as it moves around. This tech note describes the recommended method for securing the transformer to the PCB using cable ties. This modification should be performed to consoles as part of a preventative maintenance program.

Remove the console base and backlight PCB from the chassis. The PCB is drilled using the guide provided at the bottom of this document - copy the guide before use.

1. Turn the PCB so that its solder side is upward.
2. Orient the PCB so that edge with the two transformers is closest to you. Note that production version PCBs have only one transformer fitted.
3. Place the template over the PCB, ensuring that the corner marks line up with the PCB corners.
4. Mark the four holes using a scribe or other sharp instrument.
5. Drill the four holes using a M4 or 5/32 drill. Care should be used to ensure the drill doesn't damage the transformer windings when it passes through the PCB.
6. Use two 3.6mm x 200mm cable ties to secure the transformer to the PCB through the holes drilled in step 5. Note that the cable tie should be tight however excessive tightness may warp the PCB, and care should be used.
7. Cut off the excess cable tie.
8. Refit the PCB. Test for correct operation before refitting the console base.
