Date: 16th March 1999

Echelon Transistor Dissipation

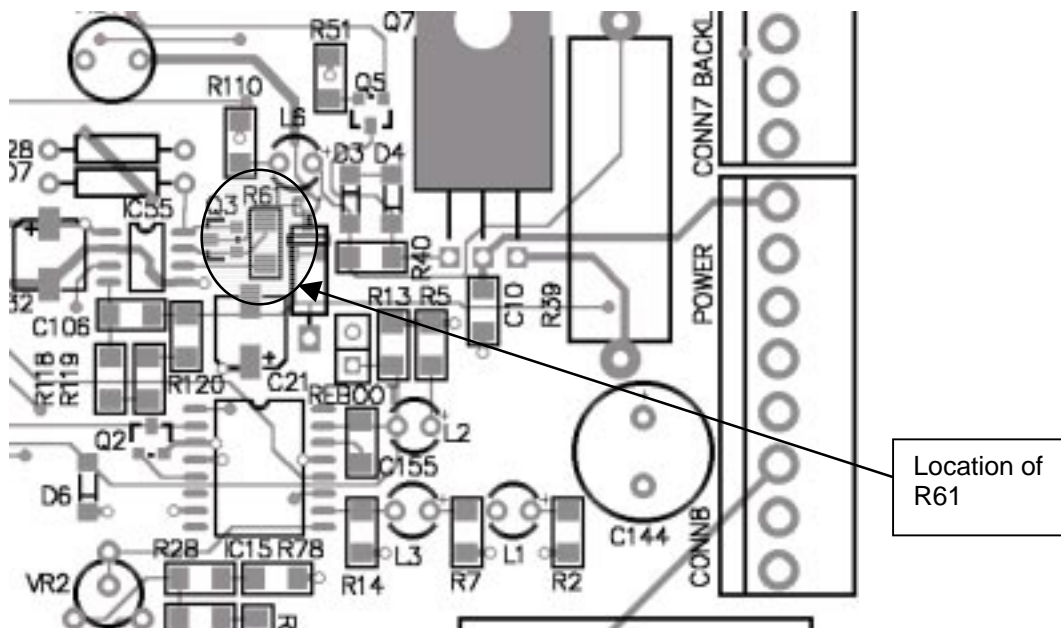
The thermal dissipation in transistor Q3 on the main CPU board has been found to vary significantly, dependant upon its manufactured gain. Failure of this transistor will result in the main LCD becoming completely black and therefore unreadable. This tech note describes a modification to reduce the transistor dissipation in low gain transistors and improve console reliability.

One x 220R 1206 SMD or 0.25W through-hole resistor

1. Save any show information
2. Switch off the console
3. Remove the base
4. Locate and remove resistor R61 near the power inlet connector on the CPU card. Refer to the diagram.
5. Solder the new resistor in location R61
6. Check for correct operation
7. Replace base
