Date: 31<sup>st</sup> August 1998

## Echelon Startup

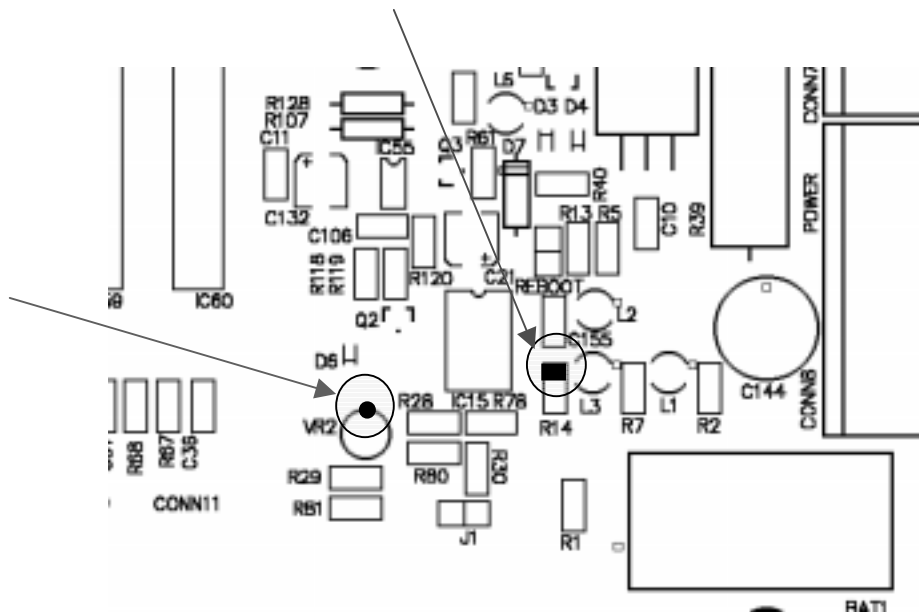
Symptom: Consoles are prone to crashing or dropping their memory on start up ie. effected consoles crash after displaying their normal boot ROM messages, or report "no show in memory" when one was known to be previously loaded. The effect may be found to be worse when desk lights are run at an intermediate level.

Add the resistor between the positions indicated on the diagram below.

Cure: Add a 1M Ohm 0.25W 5% resistor between pins 9 and 10 of IC15. This ensures the shut down sequence is properly executed.

1. Ensure any show data has been saved.
2. Remove base.
3. Locate IC15 on the CPU card near the main power inlet connector.
4. Solder the resistor between:
  - The end of R14 closest to L3
  - The wiper of VR2
5. Check for correct operation.
